## EVALUATION OF ROAD DAMAGE LEVEL USING PCI AND BINA MARGA METHOD ON BM MUDA ROAD, PADANGSIDIMPUAN CITY

# EVALUATION OF ROAD DAMAGE LEVEL USING PCI AND BINA MARGA METHOD ON BM MUDA ROAD, PADANGSIDIMPUAN CITY

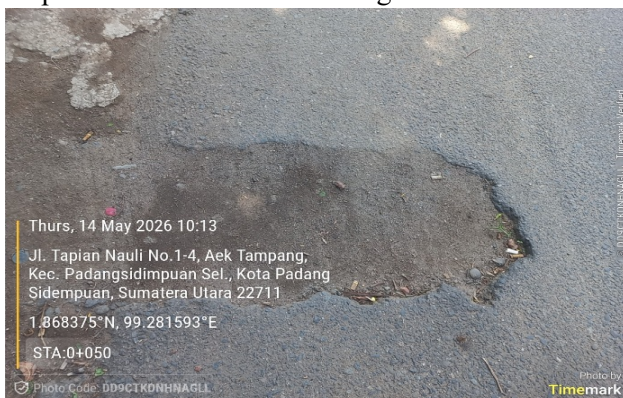
| Segmen | STA | PCI | Rating |
|---|---|---|---|
| 2 | 0+050 - 0+100 | 67.2 | Good |

Hole in Segment 2

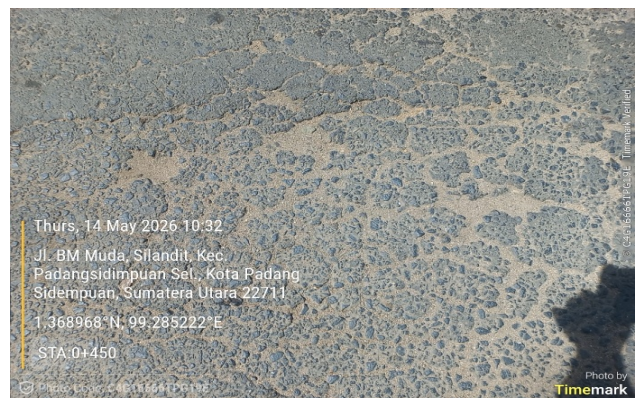
| Segmen | STA | PCI | Rating |
|---|---|---|---|
| 10 | 0+450 - 0+500 | 25 | Very Poor |

| Segmen | STA | Total number | Condition value |
|---|---|---|---|
| 10 | 0+450 - 0+500 | 12 | 4 |

Crocodile skin crack on Segment 10

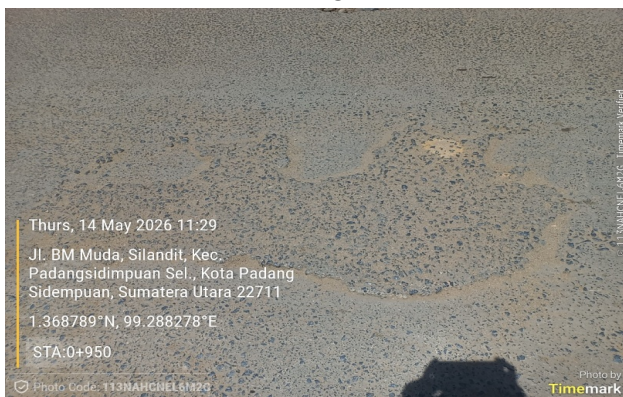
| Segmen | STA | PCI | Rating |
|---|---|---|---|
| 20 | 0+950 - 1+000 | 0 | Failed |

Patch on Segment 20
