## ANALYSIS AND MAPPING OF PAVEMENT DISTRESS ON THE SIMPANG TANAH ABANG–GALANG–SERDANG BEDAGAI BOUNDARY ROAD, DELI SERDANG

<sup>1,2,3,4</sup>Road and Bridge Design Engineering Study Program, Department of Civil Engineering  
Politeknik Negeri Medan, Medan

### Abstract

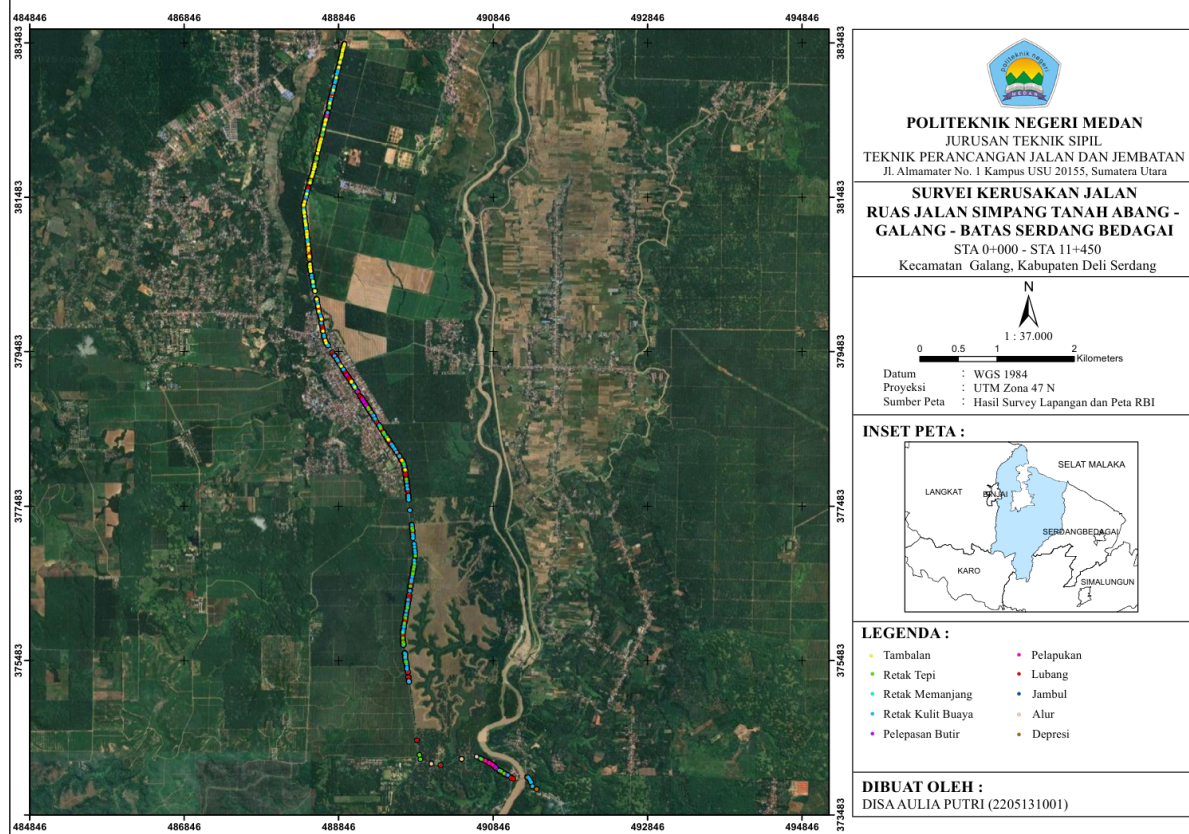
**Figure 4.** Spatial Distribution of All Distress Locations

All coordinates recorded during the survey were mapped using ArcGIS. The overview map in Figure 4 shows the distribution of 843 distress locations along the study corridor. The points were unevenly distributed and tended to cluster in particular segments. Spatial information therefore helped identify sections with a higher density of distress.

The map of all distress locations provides an overall view, but symbols may overlap where several distress types occur close together. The study therefore also presents separate maps of potholes and alligator cracking so that the distributions of these two predominant distress types can be examined independently.

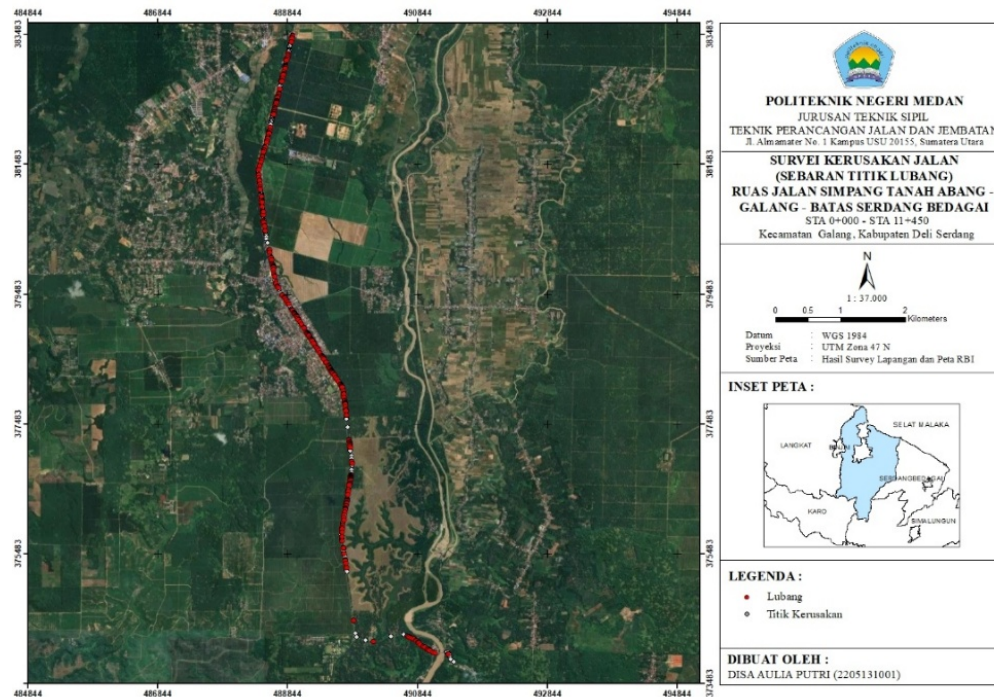
**Figure 5.** Spatial Distribution of Pothole Locations

Figures 5 and 6 show the two predominant distress types separately. This separation preserves the recorded field coordinates while reducing symbol overlap in the overall map. Potholes and alligator cracking were the main focus because of their prominence in the inventory results.

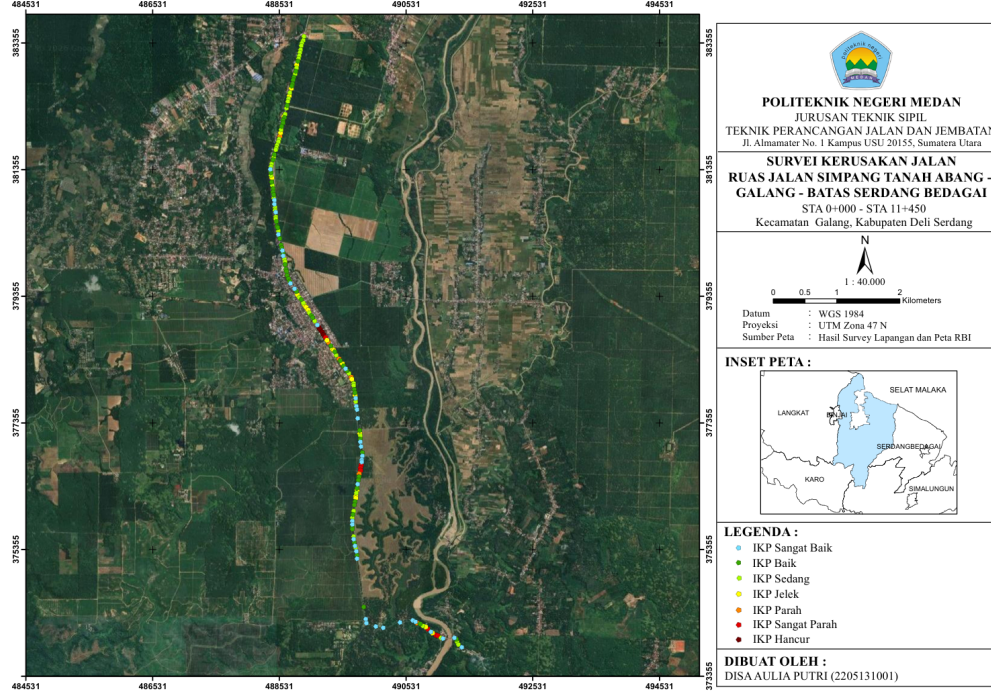
**Figure 7.** Road Conditions Based on the IKP Method

Condition values for each segment were visualized using colors corresponding to the classifications of each method. Figure 7 uses the seven IKP classes, while Figure 8 uses the four SDI classes. Both maps cover the entire 11.45-km road, allowing variations in condition to be viewed along a single corridor.

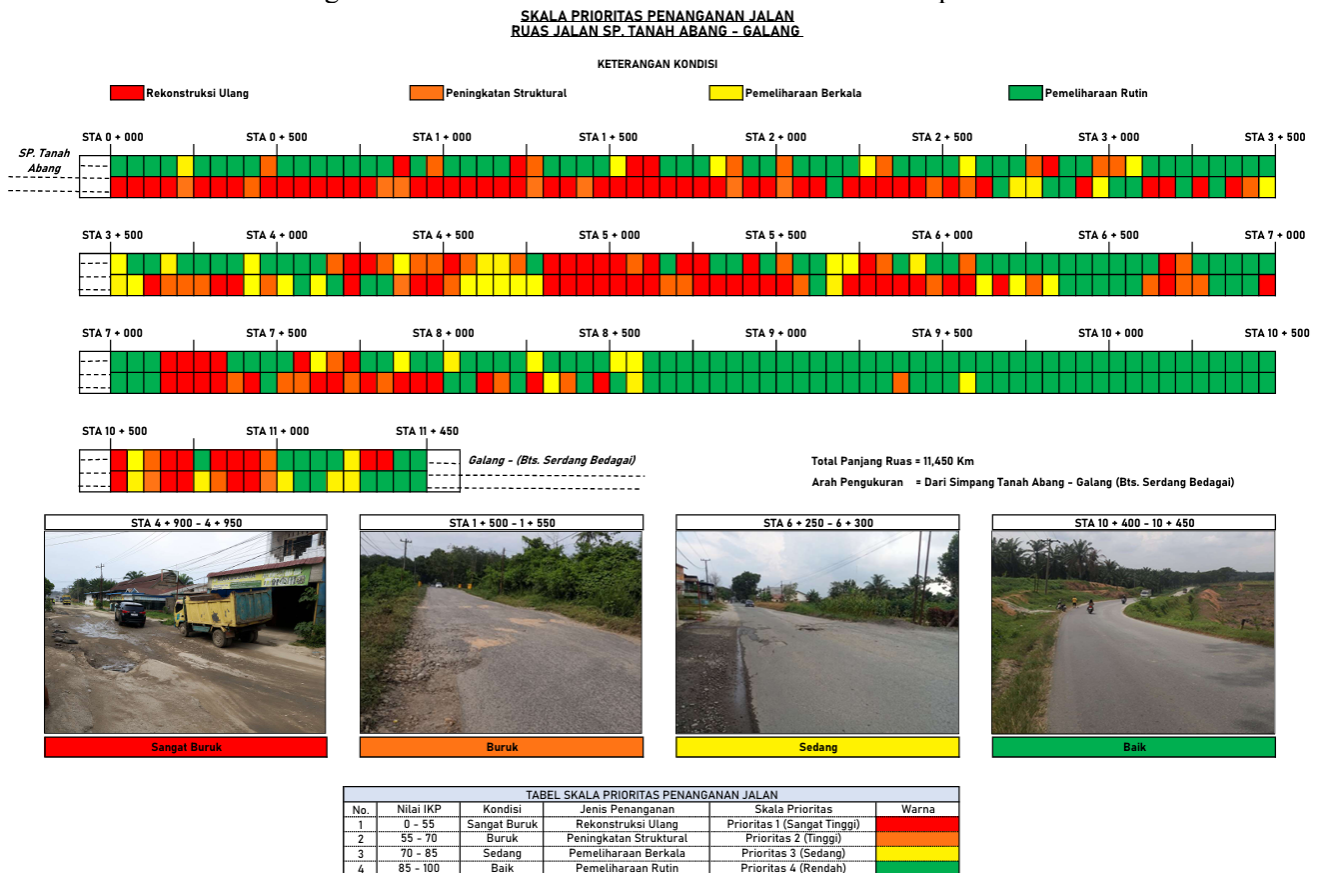
**Figure 9.** Road Treatment Priorities

The priority summary in the study conclusions recorded 128 segments (27.9%) under Priority 1, 59 segments (12.9%) under Priority 2, 48 segments (10.8%) under Priority 3, and 223 segments (48.7%) under Priority 4. Reconstruction/recycling was primarily directed toward critical segments, while routine maintenance remained necessary to preserve segments that were still in good condition.

Treatment priorities were determined by grouping the IKP results into four types of intervention: reconstruction/recycling, structural improvement, periodic maintenance, and routine maintenance. The bar chart in Figure 9 presents the priorities for each 50-m segment together with photographs of field conditions. It was prepared outside ArcGIS but used alongside the distress distribution and road condition maps.

An example of the need for major treatment was identified at STA 4+900–4+950. Structural improvement was indicated at STA 1+500–1+550, periodic maintenance at STA 6+250–6+300, and routine maintenance at STA 10+400–10+450. In the final part of the road, particularly STA 8+500–10+500, many segments fell within the routine maintenance category.
