# REINFORCED CONCRETE STRUCTURAL CAPACITY ASSESSMENT OF SWADAYA GUNUNG JATI UNIVERSITY MAIN CAMPUS USING NON-DESTRUCTIVE TESTING

The degradation of structural capacity due to the age of the building is an important issue that requires periodic evaluation, especially in public facility buildings that are actively operating such as the Faculty of Economics and Business (FEB) Building of Swadaya Gunung Jati University. This study aims to assess the capacity of the reinforced concrete structure of the building through a forensic audit based on the Non-Destructive Test (NDT) method, without physically damaging the building. The methods used include visual inspection for crack pattern identification, Schmidt Rebound Hammer (ASTM C805) testing for estimation of concrete surface compressive strength, and Ultrasonic Pulse Velocity (ASTM C597) for concrete internal integrity evaluation, followed by Pearson correlation analysis and validation using software modeling referring to SNI 2847:2019, SNI 1727:2020, and SNI 1726:2019. The results of visual inspection at 120 column points showed damage in the form of non-structural hair cracks with a maximum width of 0.2 cm. Schmidt Hammer testing yi

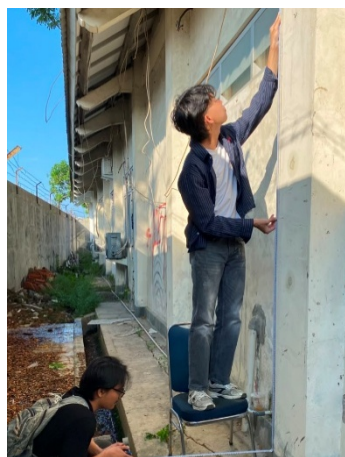
**Figure 3.** Crack Findings 1

| No. | Code | Crack No. | Visual Data | | Crack Orientation | CrackWidth | Damage Severity |
| 1. | K 1-1 B | 1 | 255 | 0,2 | Vertical | Thin | Very Slight |
| | | 2 | 110 | 0,1 | Vertical | Thin | Very Slight |
| 2. | K 1-1 C | 1 | 70 | 0,1 | Vertical | Thin | Very Slight |
| 3. | K 3-1 A | 1 | 240 | 0,2 | Vertical | Thin | Very Slight |
| | | 2 | 240 | 0,1 | Horizontal | Thin | Very Slight |

The results of the evaluation showed that the columns of the Faculty of Economics and Business Building, Gunung Jati Swadaya University were in good condition with the finding of non-structural hair cracks due to concrete shrinkage with a maximum width of 0.2 cm. Schmidt Rebound Hammer testing showed that the quality of surface concrete was dominated by  $f_c$  40 MPa (78%) and  $f_c$  36 MPa (22%), while UPV results showed that 77.50% of the elements were in the Good category. A total of 21.67% of the elements were in the Doubtful category and 0.83% of the columns were in the Poor condition which indicated the potential for the existence of voids or microcracks. Based on the re-analysis using ETABSv22 with the actual concrete quality parameters of NDT results. All column elements have adequate residual capacity with a Demand/Capacity (D/C) ratio below the critical limit so that the structure is declared safe and meets the requirements of SNI 2847:2019 and is functional.

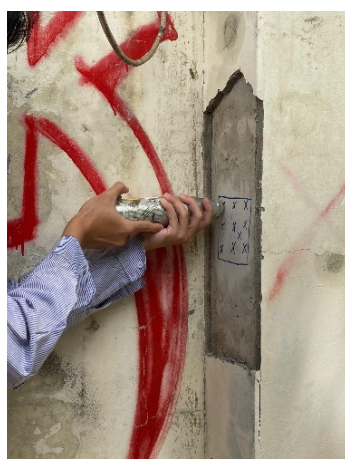
The Schmidt rebound hammer test was carried out on 120 reinforced concrete columns in the Faculty of Economics and Business Building. The K1 type column is 42 pieces, the K2 column is 54 pieces and the K3 column is 24 pieces. This test is carried out to estimate the compressive strength value of concrete surfaces in existing structural elements using the ASTM C805 standard.

The results of the test found that the compressive strength of the concrete surface was in the high quality range, with details as many as 26 columns (22%) identified as having an estimated compressive strength of  $f_c$  36 MPa, and the majority of elements, namely 94 columns (78%) reached an estimated  $f_c$  of 40 MPa.

**Figure 5.** Schmidt Rebound Hammer Test

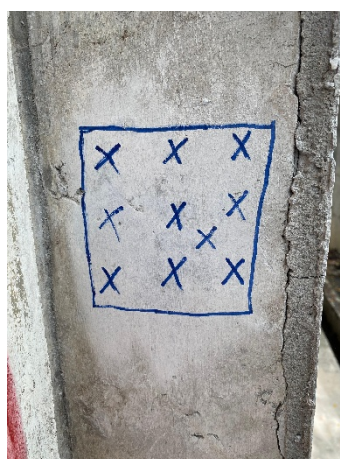
**Figure 6.** Ten Points of Punch

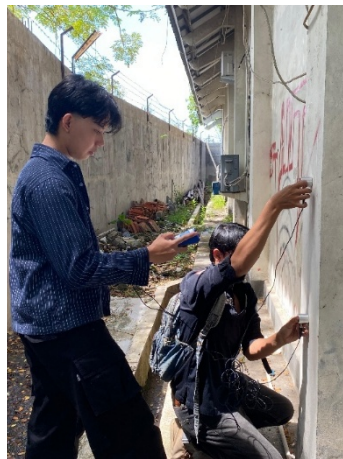
The Ultrasonic Pulse Velocity test was carried out on 120 reinforced concrete columns in the Faculty of Economics and Business Building. The K1 type column is 42 pieces, the K2 column is 54 pieces and the K3 column is 24 pieces. The transducer is placed at a distance of 50cm vertically and the highest transducer point is at an elevation of +1.5m from the floor. Calibration of the tool is 43.5  $\mu$ s. The test results showed an average ultrasonic

**Figure 7. UPV Test 1**

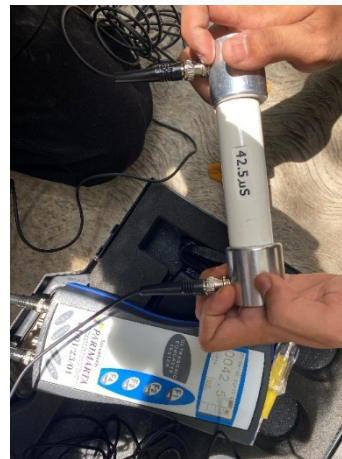
**Figure 8. Calibration**

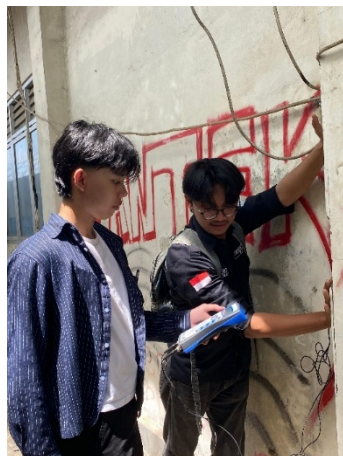
**Figure 9. UPV Test 2**

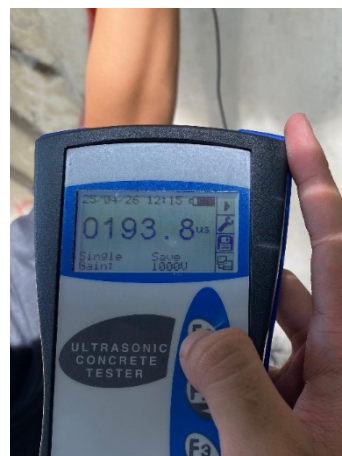
wave travel time of 132.858  $\mu$ s, with a minimum value of 111.4  $\mu$ s in columns K 2-2 P and a maximum of 193.8  $\mu$ s in elements K 1-1 B. Variations in travel time showed differences in characteristics as well as the degree of homogeneity of concrete at each test point, so these values were used to evaluate the quality of concrete. Refers to (Wang et al., 2023) The quality of concrete according to the propagation speed of UPV can be divided into five categories. The very good category with a UPV value of 4.5 km/s >, the good category with a UPV value of 3.5-4.5 km/s, the Doubtful category with a UPV value of 3.0-3.5 km/s, the Poor category with a UPV value of 2.0-3.0 km/s, and the Very Poor category with a UPV value of < 2.0 km/s.

**Figure 10. UPV Test K1-1B Results**

Based on the referred concrete quality classification standards, the test results show that the majority of the building's column structures are in safe condition. A total of 93 points (77.50%) are in the Good category, which means that most of the columns have a good level of density and a solid concrete structure. However, we still need to pay attention to the presence of a small number of points that show a decrease in quality. There were 26 points (21.67%) in the Doubtful category and 1 point (0.83%) in the Poor category. The appearance of this area of dubious

quality is in line with the finding of the highest wave travel time of 193.8  $\mu$ s. These numbers are an early indication of internal variations in concrete, such as small voids or micro-cracks in several locations. Therefore, points outside the Good category need to be the main focus for follow-up inspections to ensure the long-term safety of the building structure.
