## SPATIAL COMFORT LEVEL OF THE KH. MUSTAIN CORRIDOR PEDESTRIAN PATH

The KH. Mustain Road Corridor in Tuban Regency is a strategic route for accessing religious and cultural tourist sites. However, the pedestrian path faces several issues, including pavement damage, a lack of supporting facilities, and the repurposing of pedestrian spaces. The purpose of this research is to calculate the spatial comfort level of pedestrian paths based on pedestrian path factors, pedestrian-friendliness, and public space. The method used was field observations analyzed using the Thurstone scale and questionnaires given to 269 respondents aged between 18 and 45 years. The research was conducted on three segments of the pedestrian path, each measuring 880 meters in length on the east and west sides of the corridor. The results show that segment 1 has a comfortable spatial comfort level (average 5.078), while segments 2 and 3 have a somewhat comfortable level (average 4.622 and 4.498). While the vegetation factor contributes the most to comfort, the availability and placement of street furniture as well as the repurposing of space are the main issues. These results indicate that pedestrian paths need

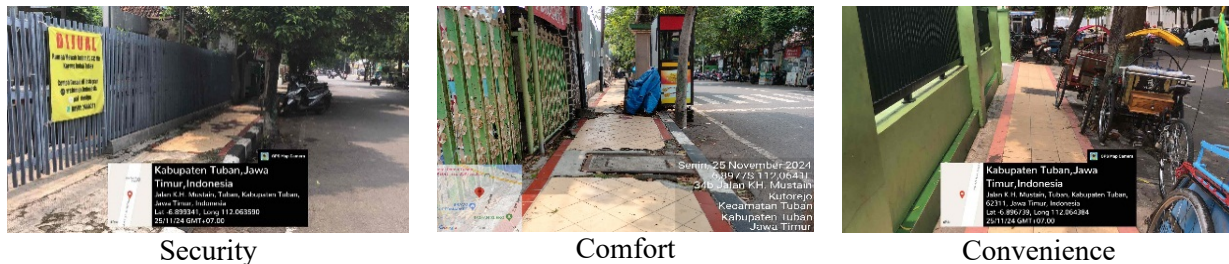
Figure 3. Condition of Pedestrian Path Segment 1

Safety , comfort and convenience is a number of aspect friendly pedestrians in the KH. Mustain Street Corridor . Aspects security covers room separated pedestrians from track Then cross vehicle and have different heights so that pedestrians can move with easy . Aspect comfort covers track with comfortable and easy width traversed (minimum 1.5 meters), surface material the path that is not slippery , 39 vegetation shade pedestrians for lower climate micro , and furniture roads and facilities room pedestrian . Figure 3-5 illustrates condition security , comfort and convenience from segments 1 to 3.

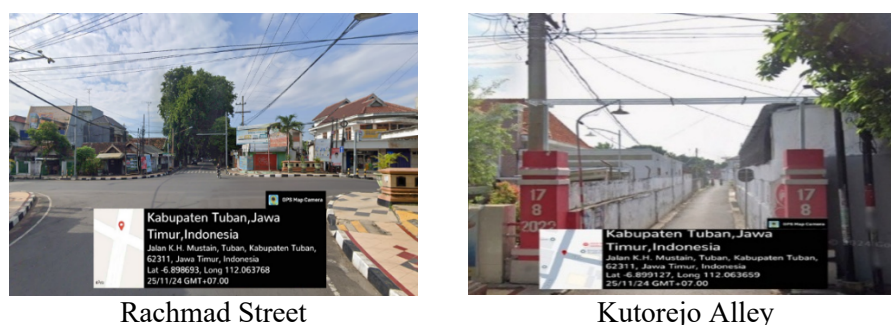
Figure 6. Starting and Ending Points of Pedestrian Segment 1

Point beginning or point end pedestrians , who were found through observation or field observations , are part from room public . Most of pedestrians start activity they with walk 43 feet from Bravo Supermarket and Jalan Basuki Rachmad , which is point beginning or point beginning of segment 1. Figure 6 shows that point end the journey in segment 1 consists of from 6 points , with point mainly located in Gang Kutorejo , Gang X Kutorejo , and Jalan Basuki Rachmad . This is due to the fact that part big pedestrians end journey they are in place the .

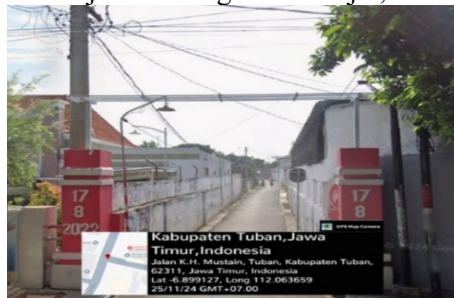
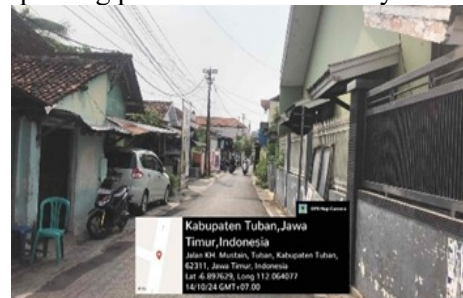
**Figure 7. Starting and Ending Points of Pedestrian Segment 2**

In segment 2 in Figure 7, the origin point or point beginning consists of from 4 points with point main movement pedestrians are in Gang Kutorejo and Gang X Kutorejo , because part big pedestrians start activity walk from place said . Point end of segment 2 consists of from 8 points with point main located on Jalan Pemuda Kutorejo Gang II, Gang Kutorejo and Gang X Kutorejo , because part big pedestrians end activity walking in place the .

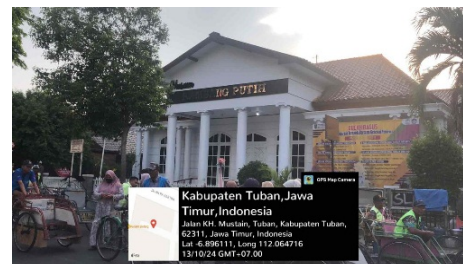
**Figure 8. Starting and Ending Points of Pedestrian Segment 3**

Origin point or point the beginning of segment 3 (Figure 8) consists of from 5 points with point mainly located on Jalan Pemuda Kutorejo Gang II, Hotel Wisata Ziarah Sunan Bonang and Hotel Indonesia Tuban , because part big pedestrians start activity walk from place said . Point end journey pedestrians consist of out of 10 points with point mainly located in the museum White Floating Bridge and RA. Kartini Street, because part big pedestrians end activity walking in place the .
