**THE IMPACT OF ROAD SPACE UTILIZATION ON ROAD PERFORMANCE ON THE  
MURADI ROAD SECTION, SUNGAI PENUH CITY, JAMBI****Yuskal Despian<sup>1</sup>, Eva Rita<sup>2</sup>, Zuherna Mizwar<sup>3</sup>**

Program Studi Magister Teknik Sipil, Fakultas Teknik, Universitas Bung Hatta

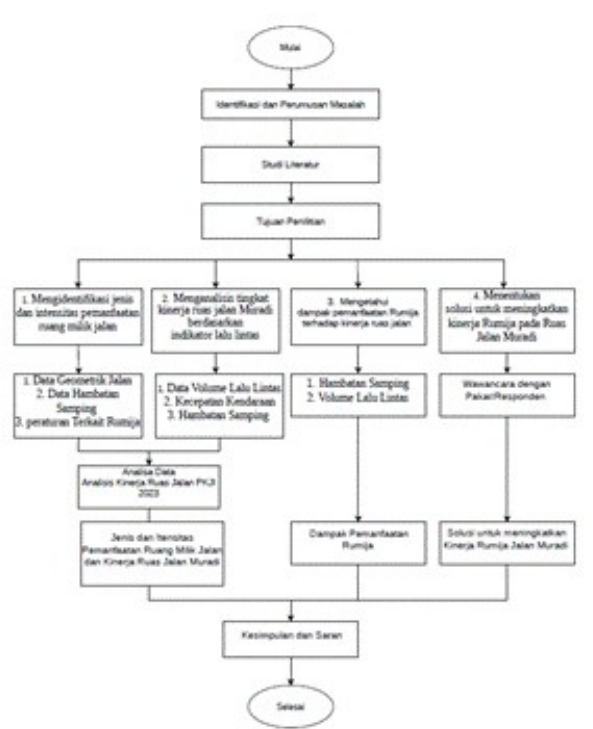
**Figure 1.** Research Flow

In conducting this research, researchers need to go through several stages of research implementation. Method scheme study Which used to solve each problem in the research is presented in the following research flowchart.

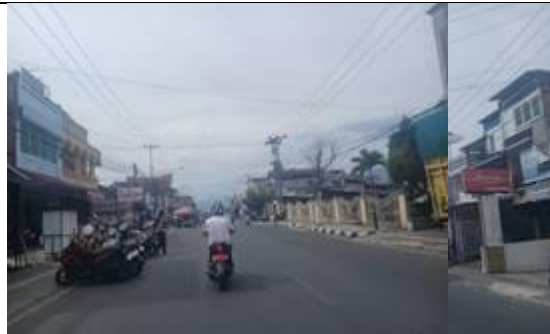
**Figure 2.** Condition of Rumija utilization on the Muradi Road section

findings the show that conflict utilization Rumija especially happen on the space that should be support smoothness per movement vehicle And road user safety. Parking on the body And shoulder road reduce wide effective traffic lanes, while the use of sidewalks by street vendors and post taxibike reduce function room pedestrian feet. This condition increases the interaction between side activities And current Then cross. In PKJI 2023, activity pedestrian foot, vehicle stop or park a vehicle in and out land side road, And vehicle slow is a side resistance component that is taken into account in the evaluation of section performance.

Results survey show that utilization Road Ownership Space (Rumija) on the Muradi Road section, Sungai City Full Not yet fully in accordance with function room road. Form the most dominant use covering vehicle Which parking on body and road shoulders, street vendor activities (PKL) And post taxibike on sidewalk r, building Which is at too near with border road, as well as closed drainage channels. On segment Station 0+000 until Station 1+000, obstacle body road reach 41.1% on side left And 37.4% on side right, whereas obstacle shoulder road reach 41.1% And 37.9%. Obstacle sidewalk on segment Which The same reach 34.6% on side left And 35.4% on right side.

findings the consistent with study Utami et al. [2] on the road section in Sungai Penuh City which shows that sidewalk And The road surface is disturbed by street vendors' activities and illegal parking. thus, utilization Rumija for non-transportation activities is not only a matter of spatial order, but has the potential to be a factor that influences traffic capacity and smoothness.
