## ANALYSIS AND MAPPING OF PAVEMENT DISTRESS ON THE SIMPANG TANAH ABANG–GALANG–SERDANG BEDAGAI BOUNDARY ROAD, DELI SERDANG

<sup>1,2,3,4</sup>Road and Bridge Design Engineering Study Program, Department of Civil Engineering  
Politeknik Negeri Medan, Medan

### Abstract

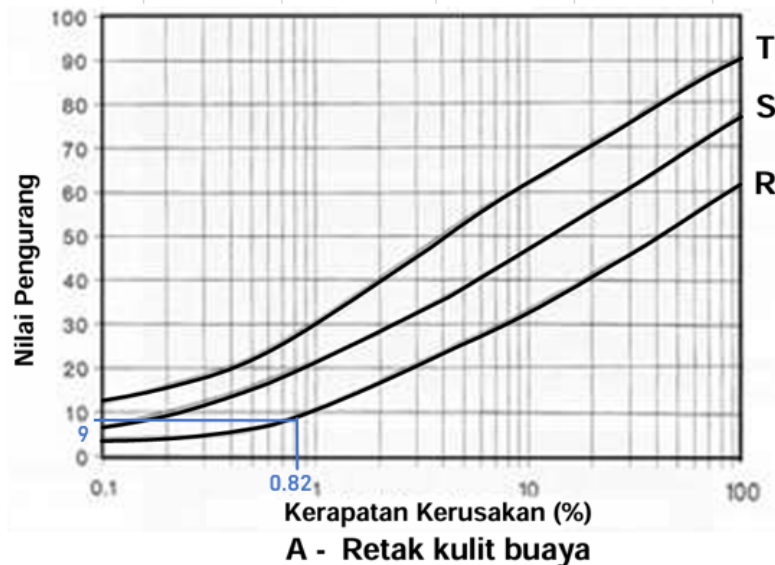
**Figure 2.** Deduct Value Curve for Alligator Cracking in Segment 139

The IKP assessment revealed conditions ranging from Good to Failed. In segment 139, STA 6+900–6+950, low-severity alligator cracking covered 1.43 m<sup>2</sup>. A distress density of 0.817% yielded an NP of 9 using the curve in Figure 2. Because only one NP exceeded 2, the total NP was used directly as the maximum NPT. The IKP value was  $100 - 9 = 91$ , placing the segment in the Good category.

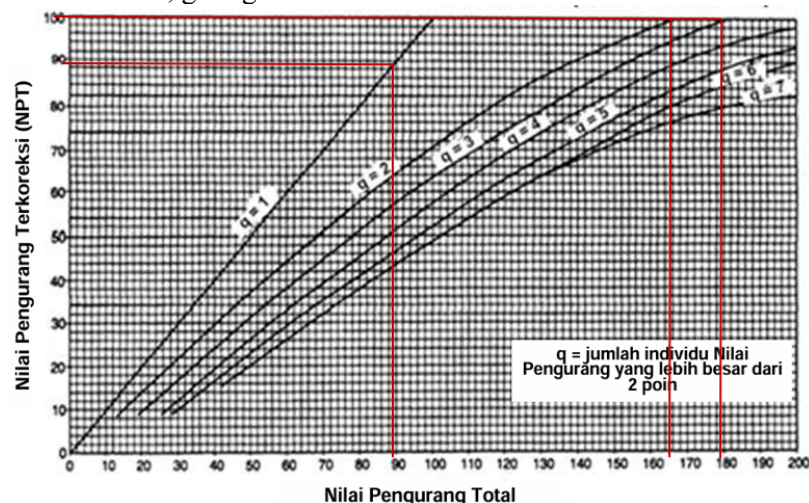
By contrast, segment 326 at STA 4+800–4+850 was classified as Failed. The unit contained high- and medium-severity potholes and high-severity raveling. The assessment yielded a maximum NPT of 100. The NPT curve in Figure 3 shows the correction results, giving an IKP value of  $100 - 100 = 0$ .
